## **Preliminary Arborist Report**

**Midway Village  
Daly City, CA**

**September 24, 2019**

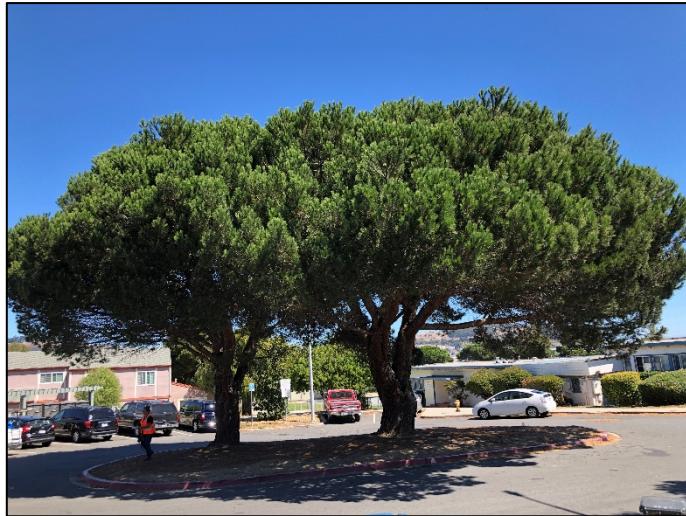
Three Italian stone pines had trunks that ranged from 27 to 43 inches in diameter. Tree #114 had fair form and structure, while trees #115 and 116 were rated in good condition, both with dense spreading crowns (Photo 1).

**Photo 1:** Italian stone pines #115 and 116, both in good condition, were the largest trees evaluated.

There may be an opportunity to preserve the two largest trees – Italian stone pines #115 and 116 – which appear to be located within the proposed resident park near the future community services center.

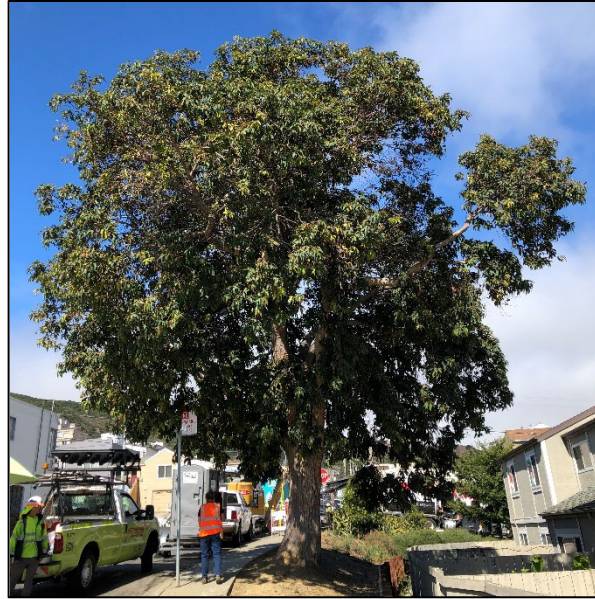
Eleven (11) Brisbane box trees were performing very well at the site. All 11 trees were in good condition with dense, healthy foliage. Ten (10) trees were young, ranging from 3-5 inches in trunk diameter. One mature tree (27" trunk) was in good condition with minor twig dieback in portions of the crown (Photo 2).

**Photo 2:** Brisbane box #81, located on Martin Street., was in good condition.

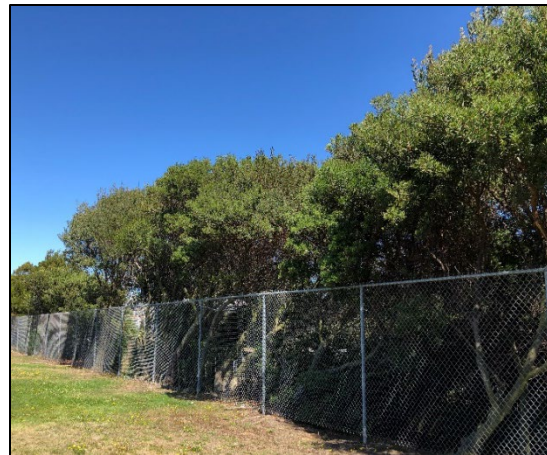
The SFPUC easement on the eastern edge of the site was inaccessible. It was densely planted with mostly blackwood acacias, as well as a few southern magnolias, willows, and toyon. There were approximately 60 trees within the easement. Trees were young to semi-mature: 47 trees had smaller than 8-inch trunk diameters; 14 trees had trunk diameters from 8 to 16 inches; only one tree had a trunk diameter of 18 inches. Some trees were growing against the fence with portions of the canopies extending over the fence (Photo 3). According to plans, the boundary of 20'-wide easement appeared to be located inside the fence line.

**Photo 3:** A dense stand of trees was growing within the SFPUC easement.

Some trees within the SFPUC easement may need to be removed if chain link fencing is relocated to actual easement boundary (closer to property line), and if adjacent improvements (e.g. EVA construction) disrupt a significant number of roots. Further evaluation of plans is necessary to determine number of trees impacted and extent of impacts.
