Geotechnical Investigation

**PRELIMINARY GEOTECHNICAL INVESTIGATION
PROPOSED RESIDENTIAL REDEVELOPMENT
MIDWAY VILLAGE
DALY CITY, CALIFORNIA**

Subject: Final Report
Preliminary Geotechnical Investigation
Proposed Midway Village Redevelopment Project
47 Midway Drive
Daly City, California 94014

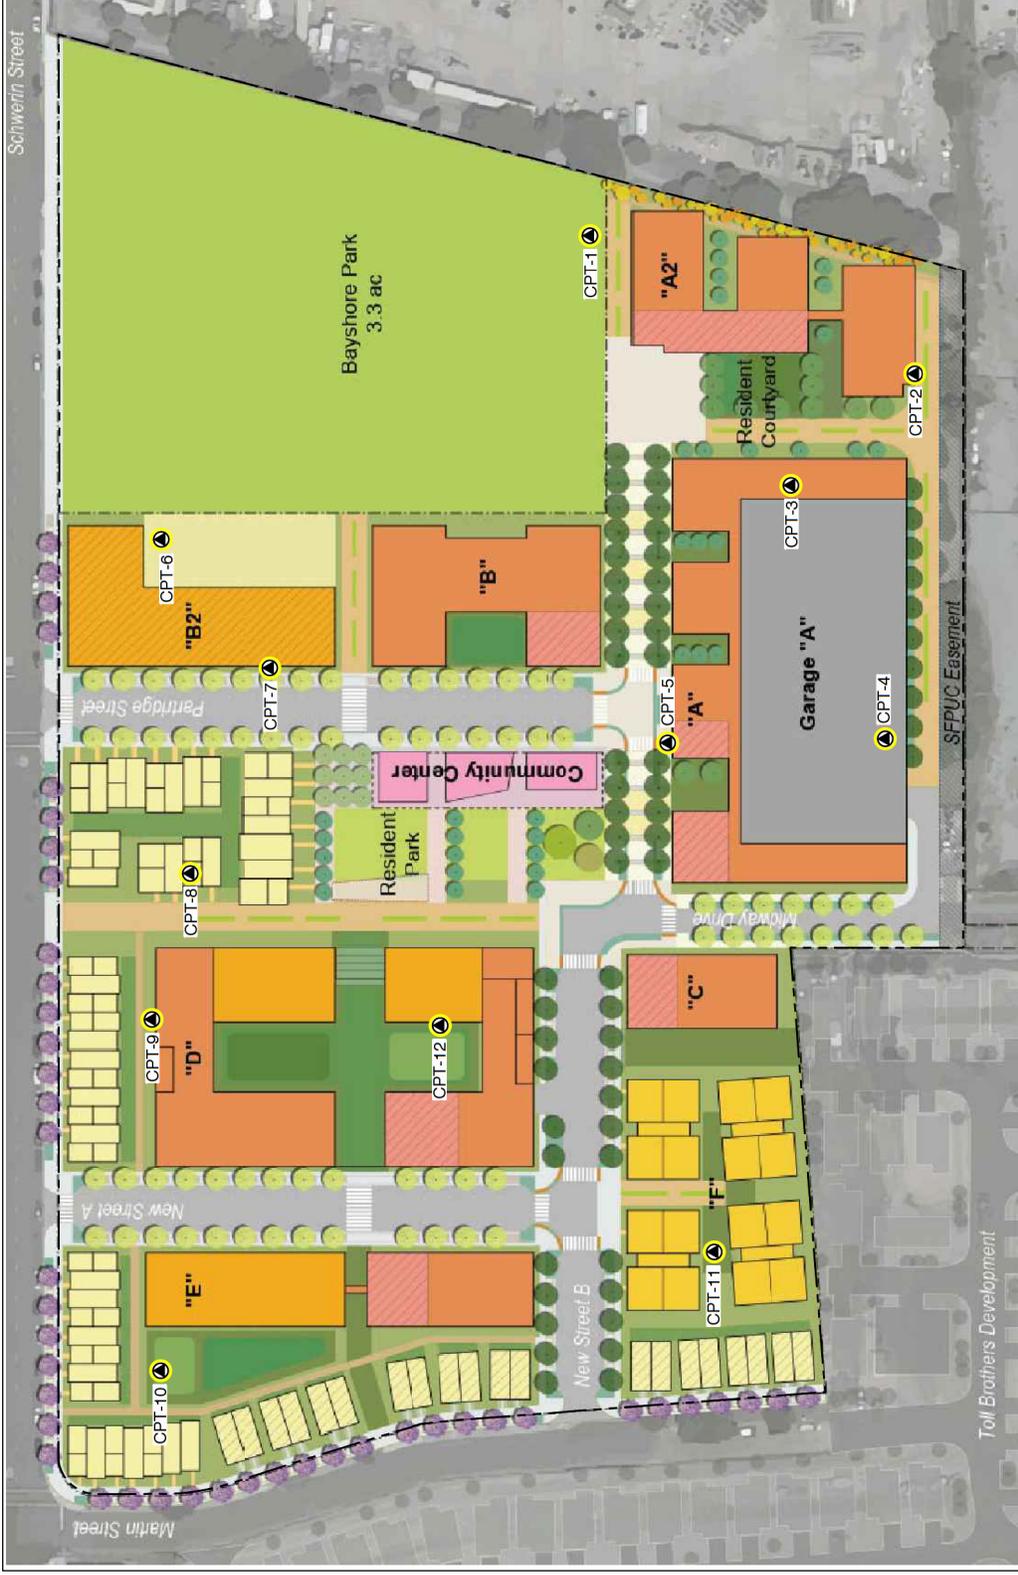
MIDWAY VILLAGE 47 MIDWAY DRIVE Daly City, California	
SITE PLAN	Project No. 18-1569
Date 02/05/20	Figure 2

- EXPLANATION**
- CPT-1
Approximate location of cone penetration test by Rockridge Geotechnical Inc., January 16, 2019
 - Project limits

Our subsurface investigation consisted of performing 12 CPTs, designated as CPT-1 through CPT-12, at the approximate locations shown on the attached Site Plan (Figure 2). Prior to performing the CPTs, we obtained a drilling permit from the City of Daly City and contacted Underground Service Alert (USA) to notify them of our work, as required by law. We also retained Precision Locating, LLC, a private utility locator, to check that the CPT locations were clear of buried utilities.
